Structural Safety Inspection

Factory Name	MASCOTEX LIMITED	Accord ID	9505
Factory Address	Shataish Road, 31/32, Khartail, Tongi		
Inspection Date	08/04/2014		
Date of Review Inspection	8-Aug-18		
Inspected by	U.S.M. Dilruba Mahmud

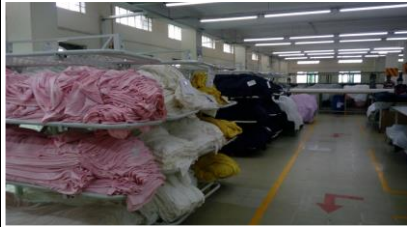
Item No	Accord Observation	Accord Recommendation	Accord Timeline	Final Action Plan	Final Timeline(D/D/MM/YY YY)	Comments after Physical Inspection	Progress Status	Pictorial Evidence
5	No loading plan in place	Factory Engineer to produce and actively monitor a loading plan for all floor plates within the factory complex, with consideration given to slab, column and foundation capacities	(within 6 – weeks)	This has been done.	'10/02/2015	<p>On 03/09/2014: Factory Engineer have produced a load plan which attached with DEA.</p> <p>On 25/01/2017: The Load plan of this building had been reviewed and accepted by Accord on 08 Sep, 2016.</p> <p>On 08/08/2018: This issue has been corrected as per 2nd follow up inspection. Load plan has been prepared as part of DEA which was accepted on 08/09/2016. However, load was found below 2 kPa.</p>	Corrected
